Manhole Inspection Summary

Manhole # **S17C__005MH**

Insp Date: **2/28/08 12:21 PM**

Location Address: **REAR OF 2500 EDMONSON AVE** Cross Street: **WARWICK AVE**

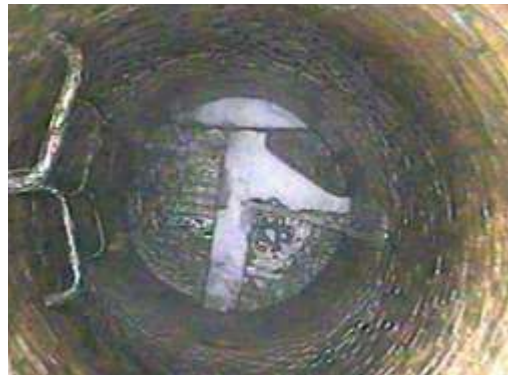
Defect 2

Steps Count: **8** Missing: **0** ☒ **Corroded**

STEPS CORRODED

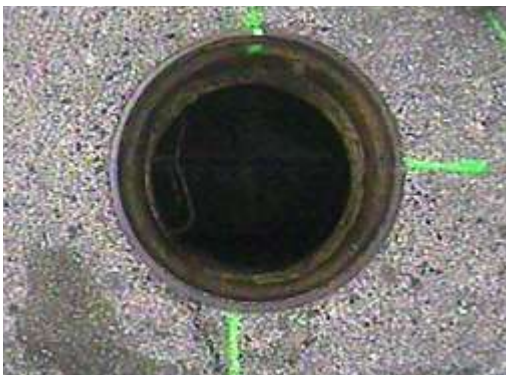
Defect 1

Frame Offset: **1** (in.) Condition: ☒ Sound ☐ Cracked ☐ Leaks

FRAME OFFSET

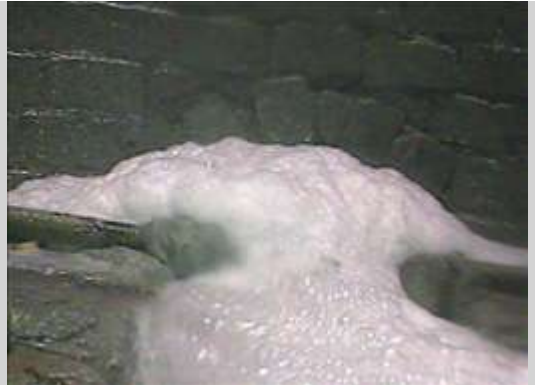
12 O'Clock Outflow

8 in. Circular Gravity Sewer
Pipe Out @ 12 O'Clock

Pipe Height: (in.) Direct
Pipe Material: **Clay** ☐ Pipe Lined
Invert Depth: **11.97** (ft.) Flow Characteristics: **Fast**
Deposits: ☒ None ☐ Mud ☐ Sludge ☐ Debris ☐ Grease
Silt Depth: (in.) Deposits Extent:
Infiltration: **None** Pipe Seal Cond: **Unknown**

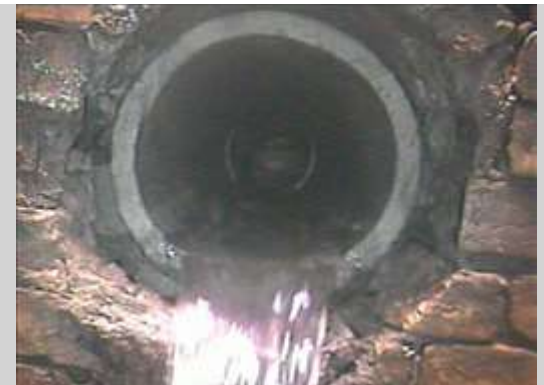
3 O'Clock Inflow

8 in. Circular Gravity Sewer
Pipe In @ 3 O'Clock

Pipe Height: (in.) Direct
Pipe Material: **Clay** ☐ Pipe Lined
Invert Depth: **8.02** (ft.) Flow Characteristics: **Fast**
Deposits: ☒ None ☐ Mud ☐ Sludge ☐ Debris ☐ Grease
Silt Depth: (in.) Deposits Extent:
Infiltration: **None** Pipe Seal Cond: **Sound**

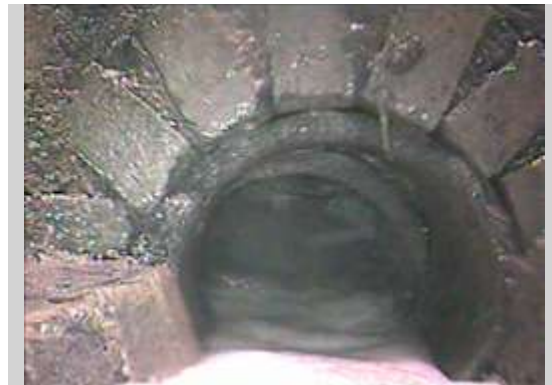
Drop In @ 3 O'Clock

Drop: **Outside Direct**

Inv Depth: **11.90** (ft.)

Drop Condition: **Clogged**

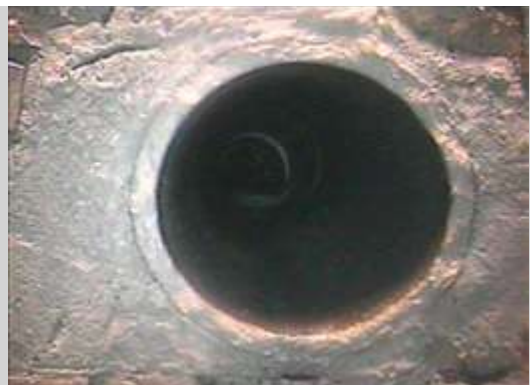
6 O'Clock Inflow

Pipe In @ 6 O'Clock

Invert Depth: **9.02** (ft.) Flow Characteristics: **Slow**

Infiltration: **None** Pipe Seal Cond: **Sound**

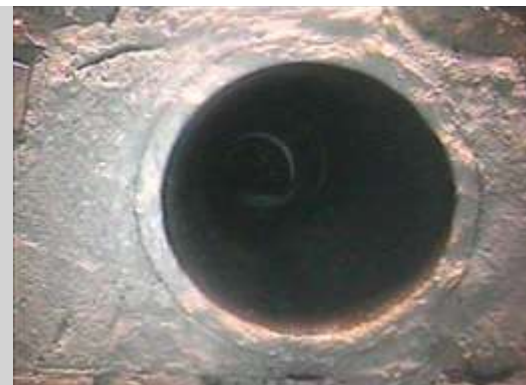
Drop In @ 6 O'Clock

Drop: **Outside** **Direct**

Inv Depth: **12.00** (ft.)

Drop Condition: **Open**
